Ashbridges Bay Treatment Plant Landform

Presentation Outline

Ashbridges Bay Landform Project - Habitat Enhancement Plan

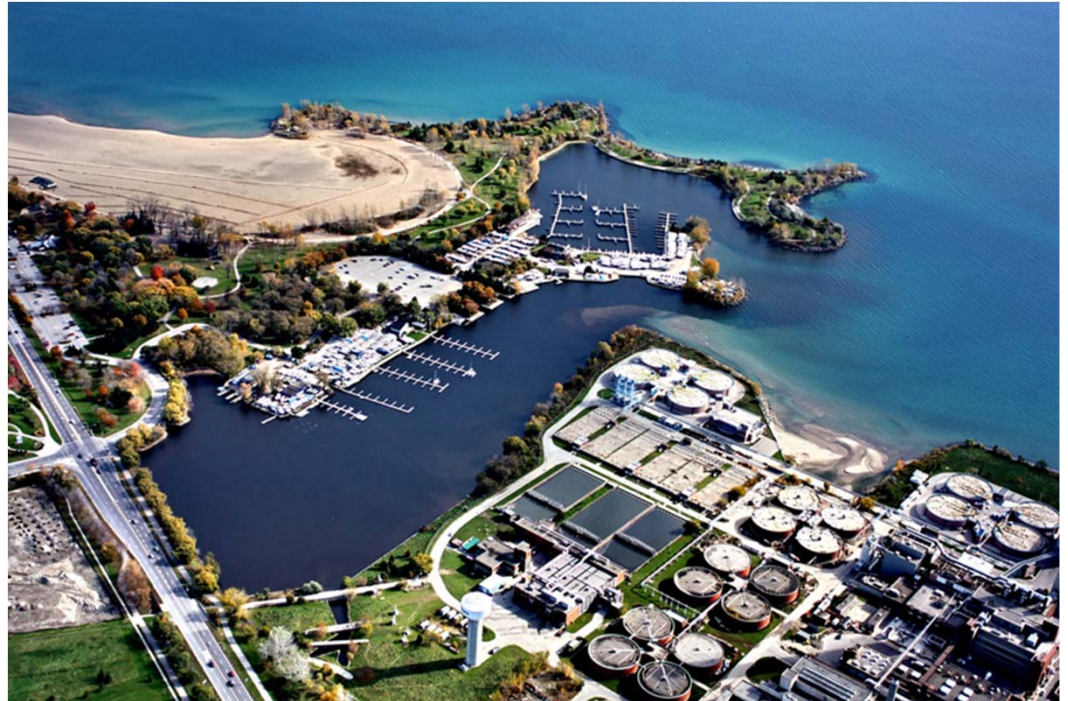
Class EA Objective (2014)

To identify a preferred solution that will mitigate the risk to navigation due to sediment erosion and deposition at the harbour entrance of Ashbridges Bay and Coatsworth Cut while considering the various approved facilities , planning initiatives and current uses in the study area.

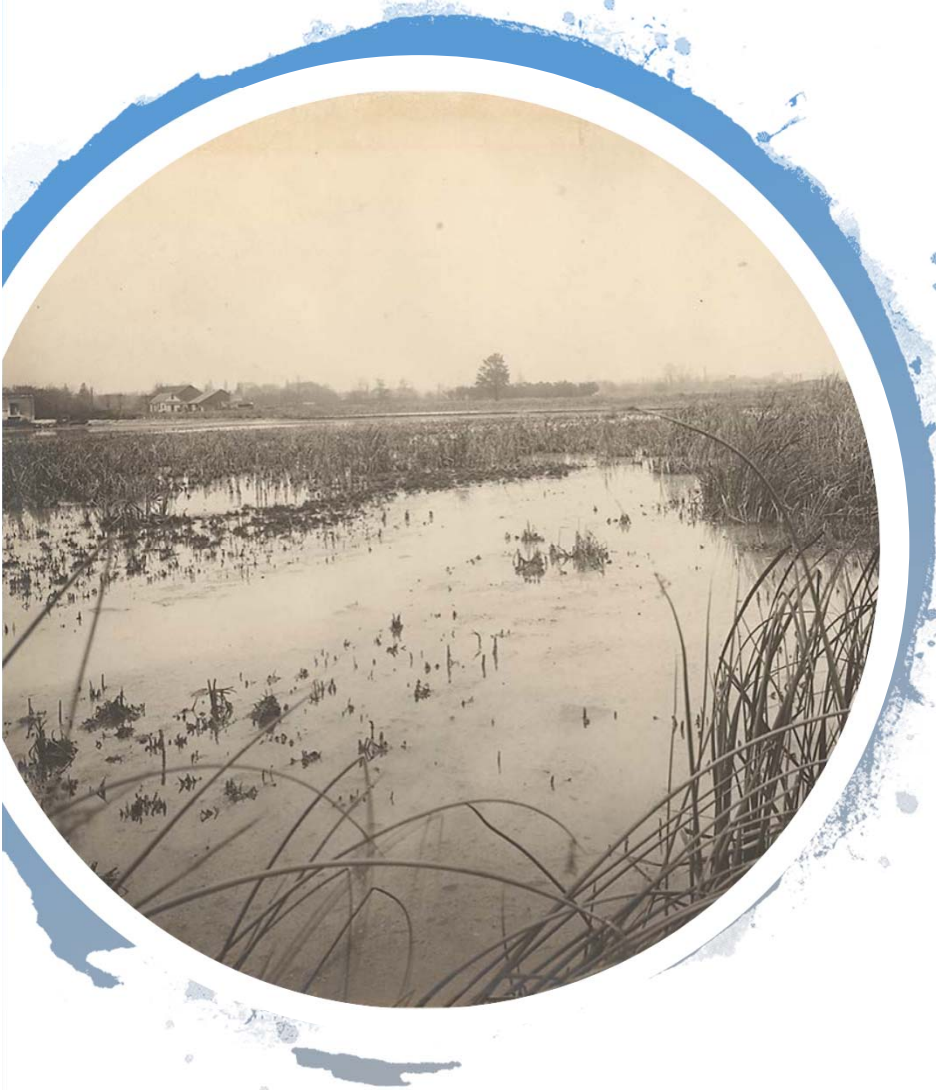
- Historically, Ashbridges Bay was a large marshland complex, originating as a delta formation at the mouth of the Don River.
- Before filling of the Bay began in the early 20th century, the fish community was linked to the Don River watershed.
- Today it is an open coast habitat, characterized by extensive wind and wave action and cold water - generally, fish production in open coast habitats is limited due to wave action, lack of structural habitat and rapidly fluctuating temperatures.
- Sheltered embayments exist at the Ashbridges Bay Yacht Club basin and Coatsworth Cut - In contrast to the open coast environment, sheltered embayment habitat is characterized by a lack of intense wave action, a substantial amount of riparian and aquatic vegetation, shallow water depths and warm to cool water temperatures.

Ashbridge's Marsh looking northeast, circa 1909
City of Toronto Archives, Series 376, File 4, Item 63

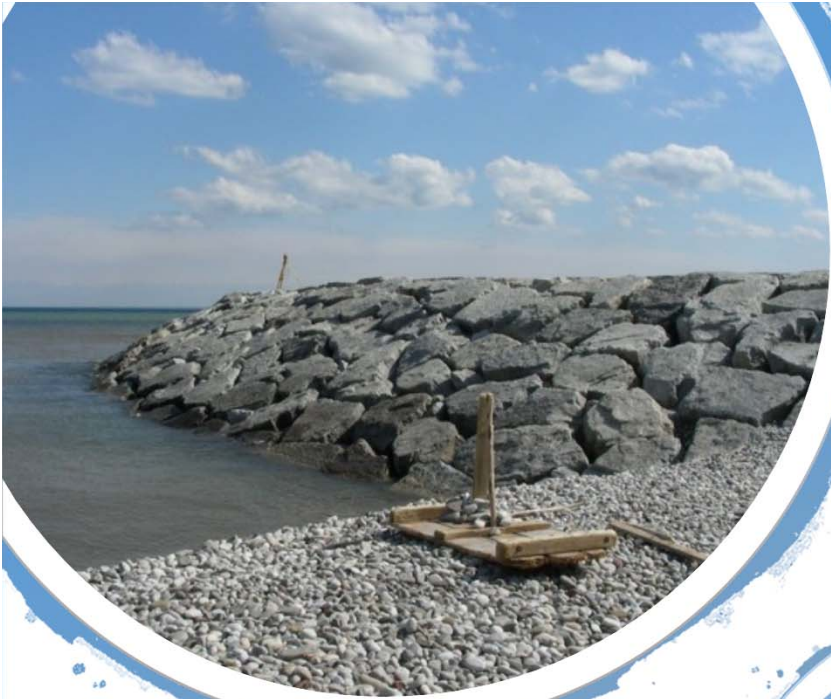
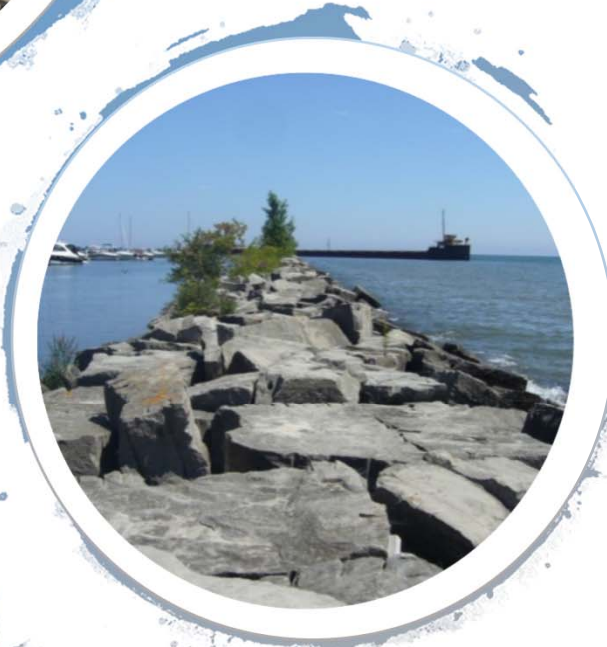
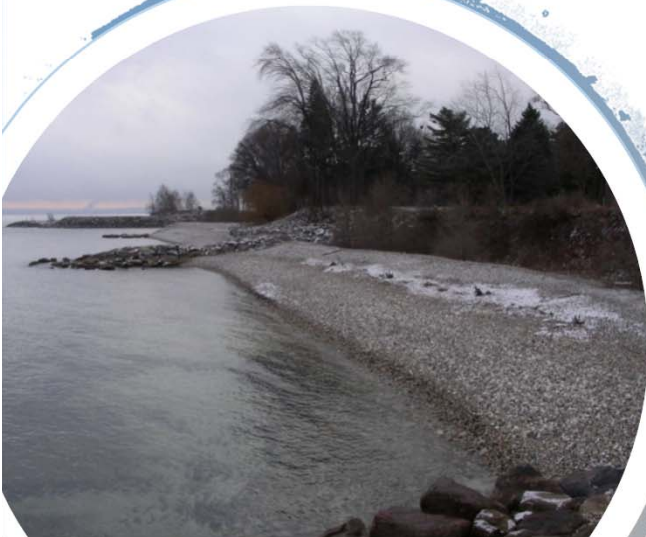
Breakwater and Shoreline Examples

Port Credit (below)
Burloak Waterfront Park, Burlington
(both at left)
