# Gibraltar Point Erosion Control Project

Lake Ontario Evening, May 14 2019

Presented by: Meg St John, Senior Project Manager

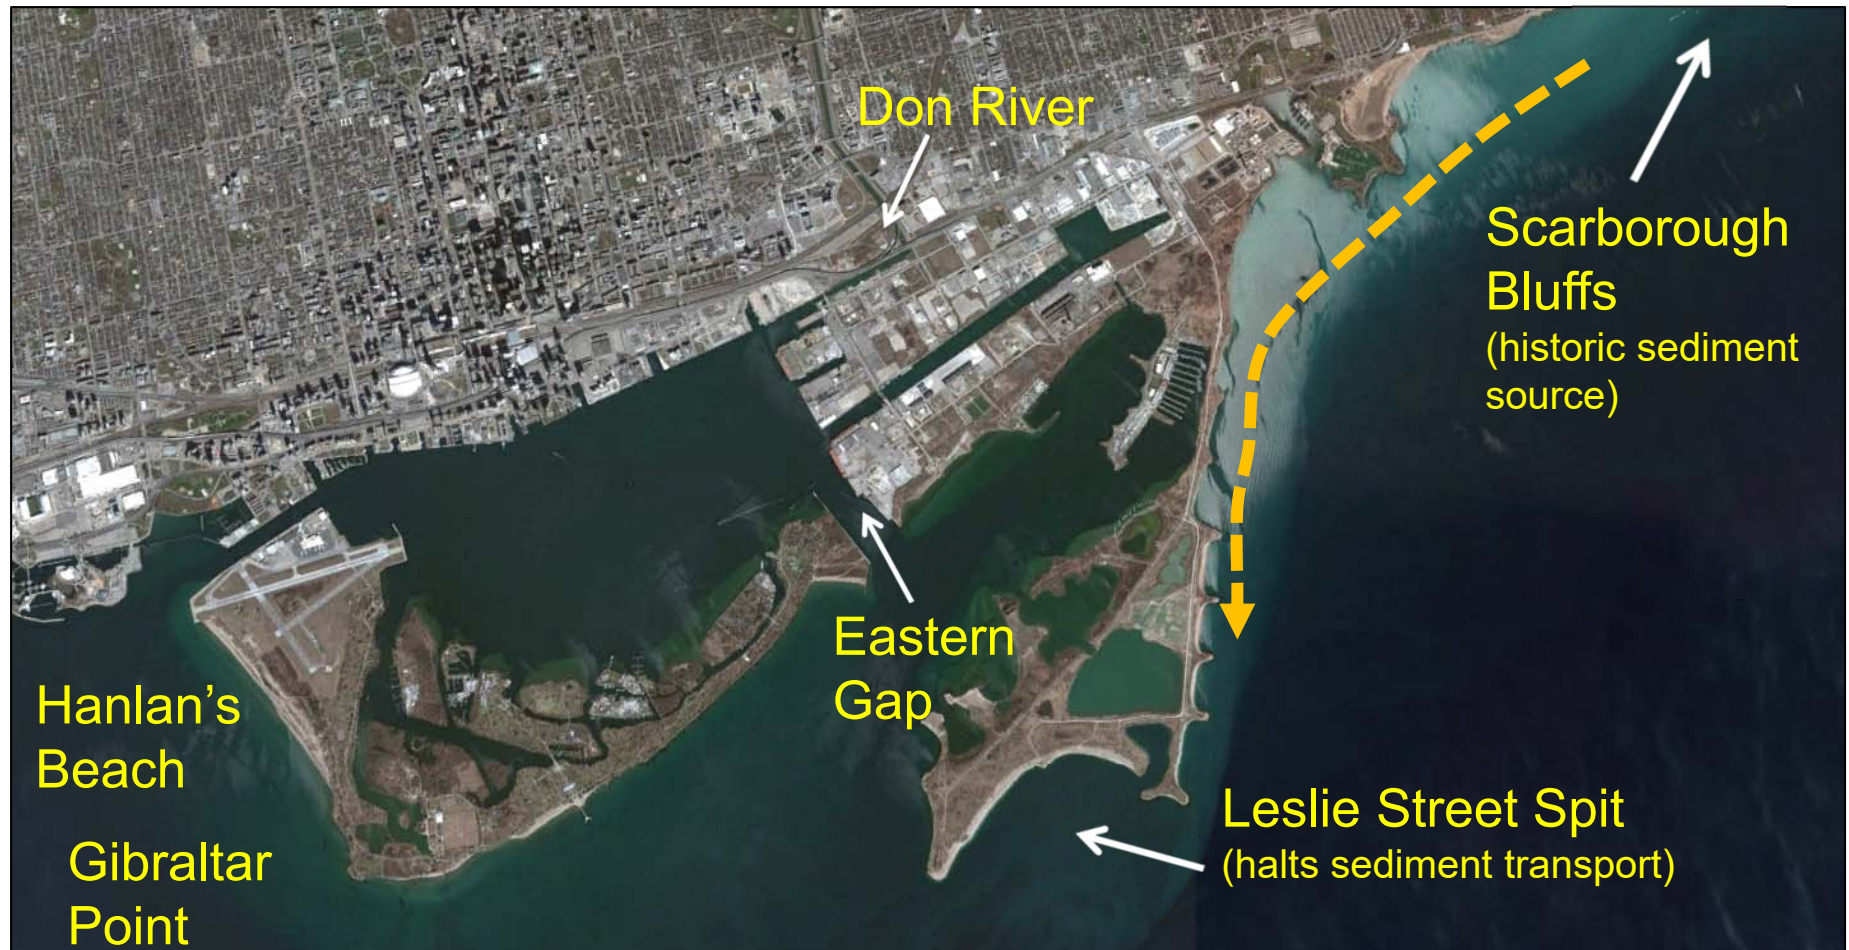
# Toronto Islands

- Historic sediment sources included the Don River and the Scarborough Bluffs
- Today, the Islands are mostly cut off from these sediment sources

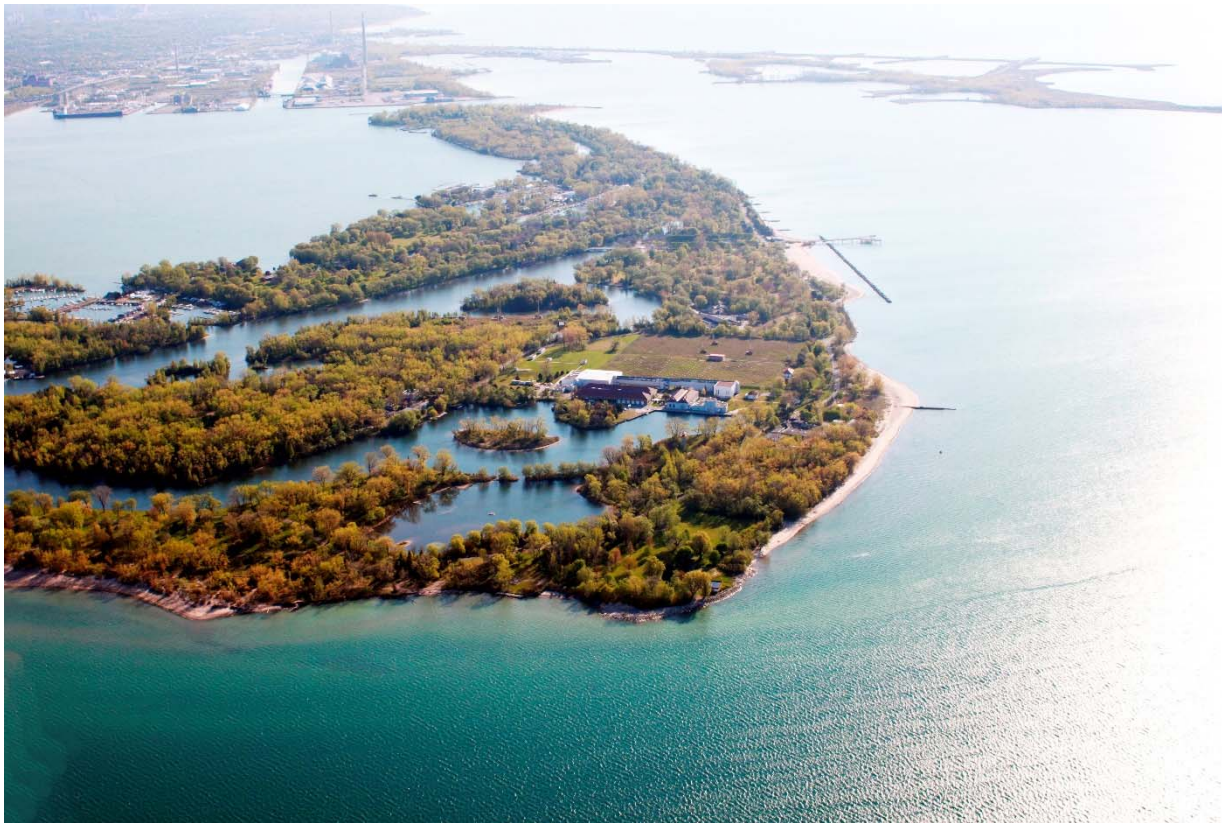
# Gibraltar Point Erosion Control Project - background

- Initial Environmental Assessment started in 2004 and approved in 2008
- Addendum approved in 2018

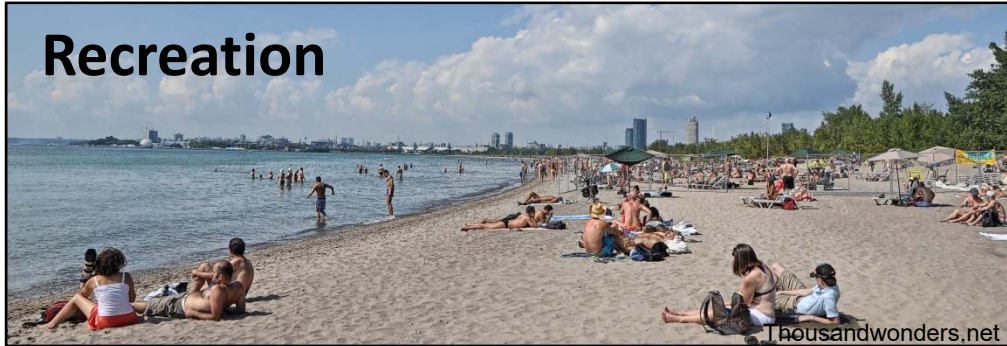
**Recreation**

# Impacts of Erosion at Gibraltar Point

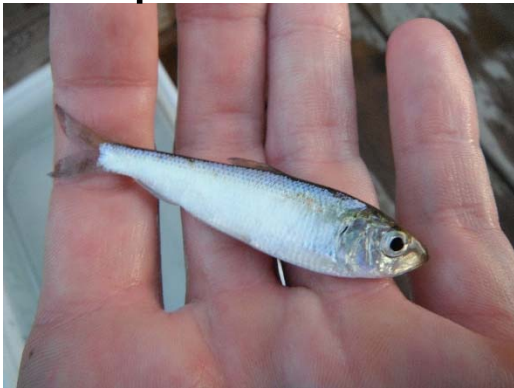
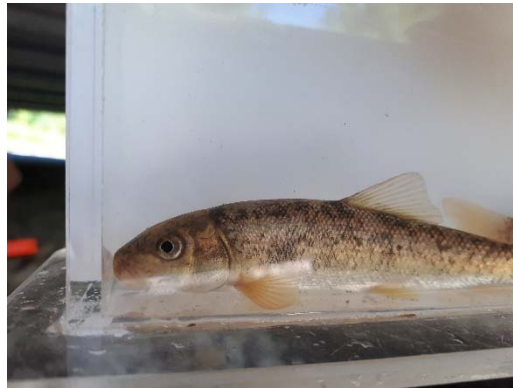
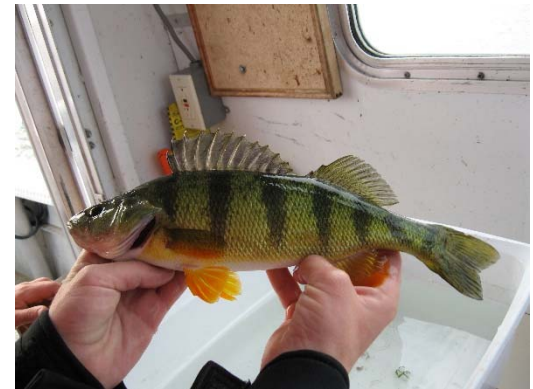
# Nearshore reef as aquatic habitat

- The creation of the nearshore reef follows the recommendation of Toronto Waterfront Aquatic Habitat Restoration Strategy to create reefs in open coast areas.
- The creation of the reef will lead to an increase in essential habitats for coolwater and coldwater species.

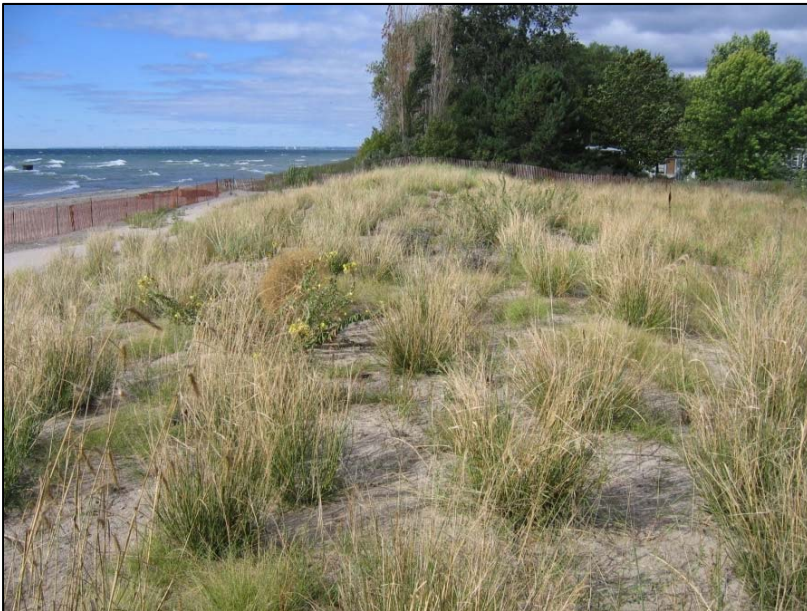
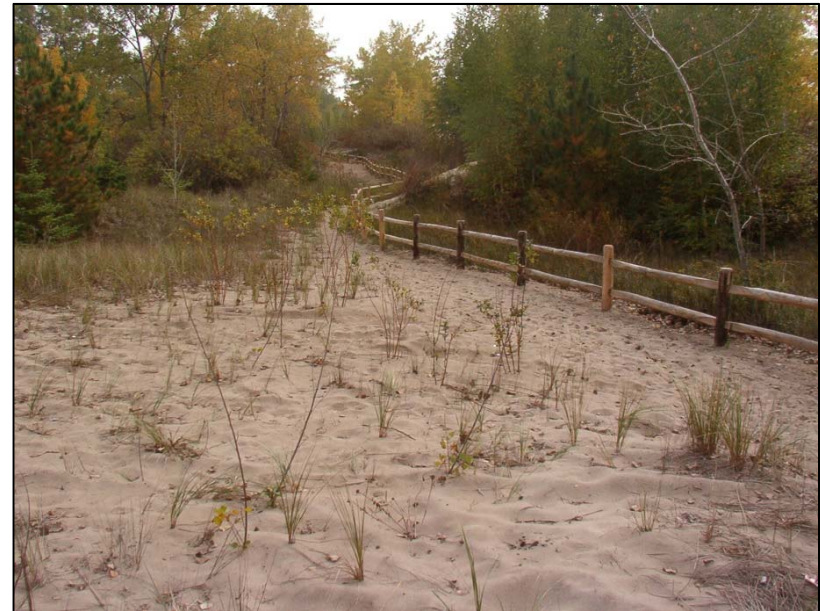
# Beach restoration at Gibraltar Point

- Nearshore reef combined with a dune beach restoration plan
- Beach design will mimic existing dune habitat

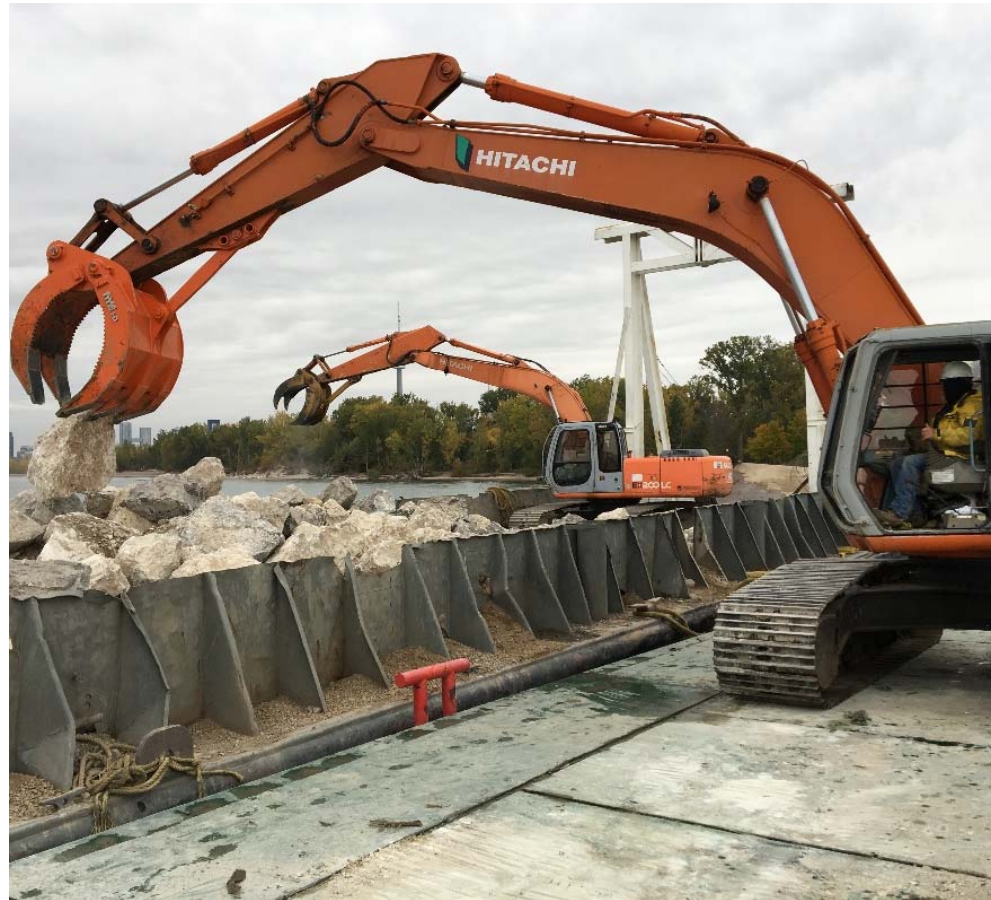
# Gibraltar Point Erosion Control Project - timeline

- Stone placement started October 24, 2018
- Nearshore reef to be completed by end of 2019
- Groyne to be built in 2020
- Beach restoration 2021
